## SERVICE BULLETIN

DATE: September 9, 2026 Service Bulletin No. 671A  
(Supersedes Service Bulletin No. 671)  
Engineering Aspects are FAA Approved

SUBJECT: Fuel Pump Leak Inspection and Diaphragm Replacement,  
Hartzell Engine Tech (HET) Alert Service Bulletin No.233

## 200F, 201F, 202F, & 500F Fuel Pump Leak Inspection and Diaphragm Replacement

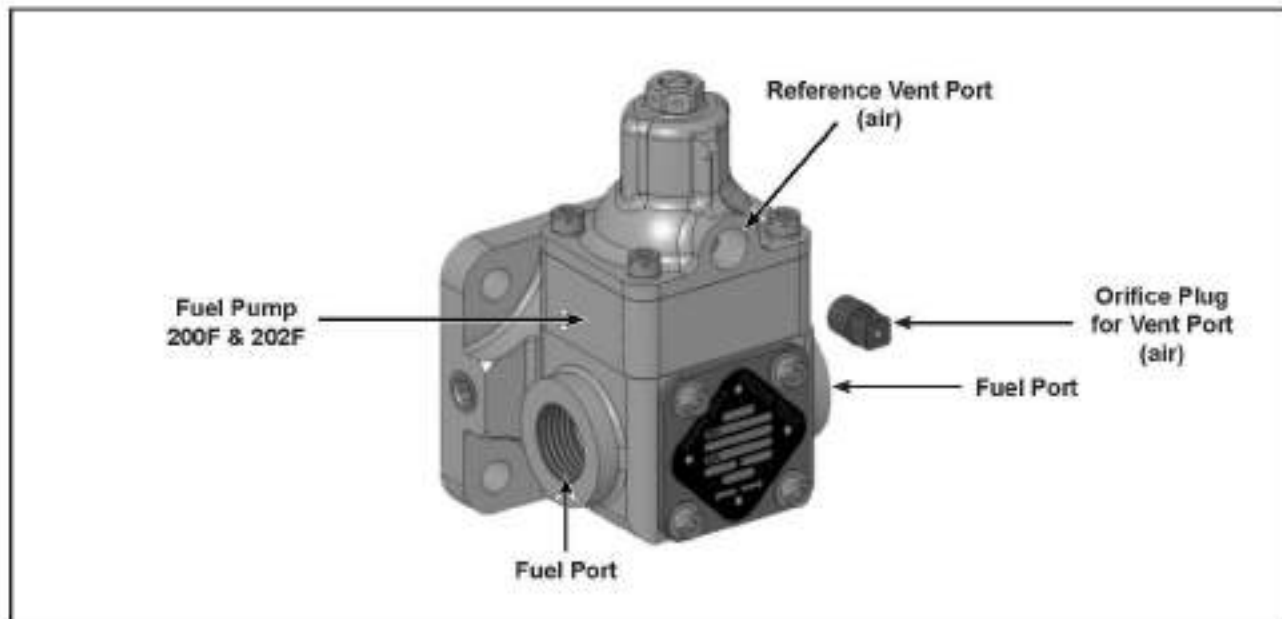
Figure 1 - 200F & 202F Identification

- (1) Prior to next flight:
  - (a) Inspect the vent reference port and surrounding area on the exterior of affected fuel pumps for indications of fuel leakage, such as staining or wetting of the port. See Figures 1 thru 3.
    - 1) For Aviation Gasoline power engines staining will be blue in color.
    - 2) For kerosene powered engines, leakage will show as an oily film or pools in low areas.

- 3) If fuel leakage at the fuel pump reference port is found, refer to Option 1 or Option 2:
    - a) **Option 1:** The affected fuel pump must be repaired by installation of a new diaphragm prior to next flight. Refer to Table 1 of this ASB for materials required.

- b) **Option 2:** The affected fuel pump must be replaced with one not affected by this ASB prior to next flight.
  - 4) If fuel leakage at the fuel pump reference port is not found:

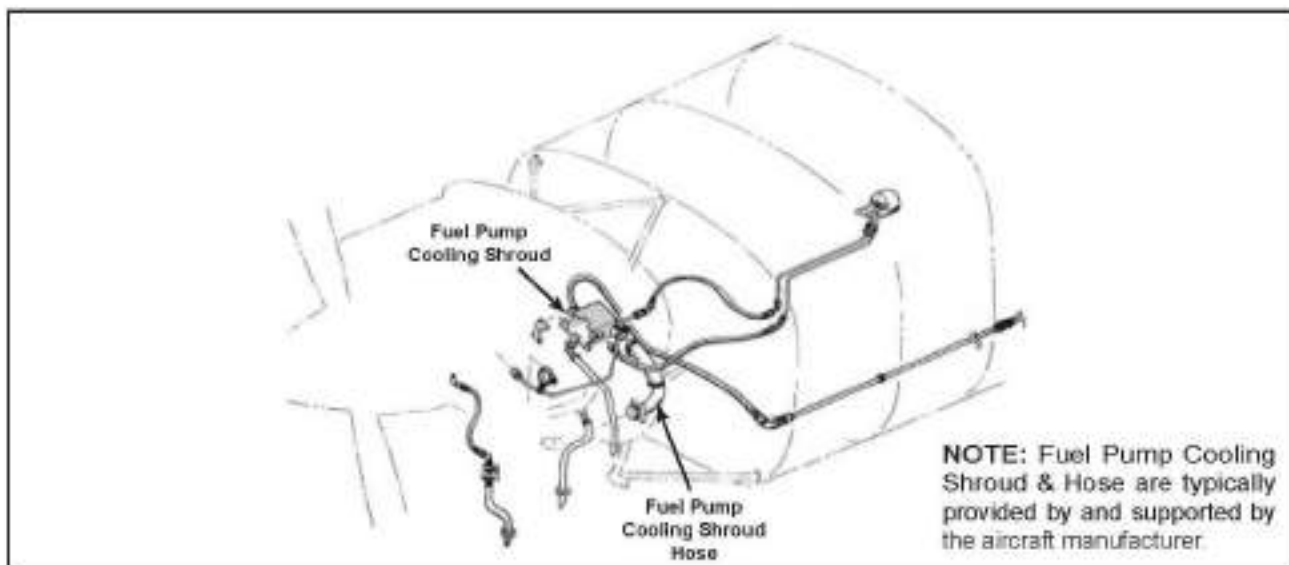
Figure 4 - Typical Cooling Shroud Installation

- (2) Inspection for fuel or blue dye stains may require use of a "Q" tip cotton swab or similar device to check for the presence of fuel or blue dye.
- (3) If fuel or blue dye stains ARE NOT found:
  - (a) Continue inspection interval in accordance with 1.E.(1)(a), Compliance, or, continue to 3.C., Corrective Action.
  - (b) Reassemble the connection for the upper deck reference or the engine turbocharger reference lines.
  - (c) If removed, reinstall the fuel pump cooling shroud and air hose (if applicable) in accordance with the latest engine/airframe service instructions or maintenance manual and continue to 3.D.(1), Return to Service. Refer to Fig. 4.
