## SERVICE BULLETIN

DATE: October 8, 2026 Service Bulletin No. 639A  
(Supersedes Service Bulletin No. 639)  
Engineering Aspects are FAA Approved

SUBJECT: Inspection of Rocker Arm, Part Number LW-15014

MODELS AFFECTED: O-320-H2AD, O, LO, TO, LTO-360-E1A6D new, rebuilt, or overhauled engines shipped from Lycoming since June 2017 with less than 500 hours of operation or engines with less than 500 hours of operation since rocker arm replacement

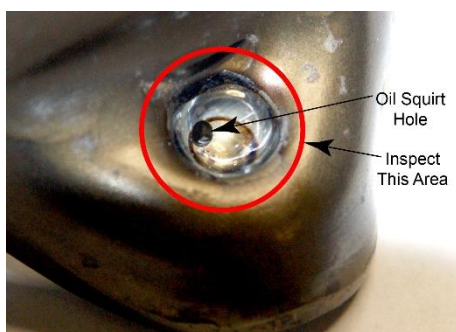
2. Clean residual oil from the rocker arm.
3. Use a 10X power magnifying glass to inspect the pushrod socket and the outside of the rocker arm for cracks around the oil squirt hole (Figures 1 and 2).

**Figure 1**  
**Area to Inspect**

**(Pushrod Socket Side of the Rocker Arm)**

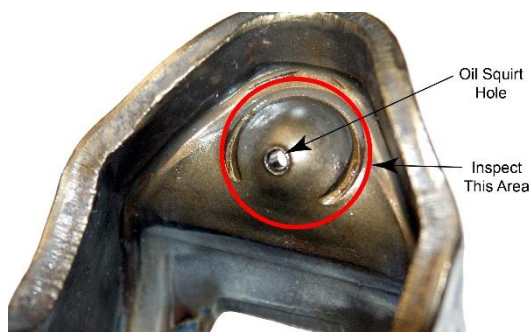
**Figure 2**

**Area to Inspect**  
**(Outside of the Rocker Arm)**

- D. Complete the following inspection at next 50-hour oil change until 500 hours of engine operation. Rocker arm disassembly is not required after initial inspection.
  - a. Clean residual oil from the rocker arm.
  - b. Use a 10X power magnifying glass to inspect the outside of the rocker arm for cracks around the oil squirt hole (Figures 2 and 4).

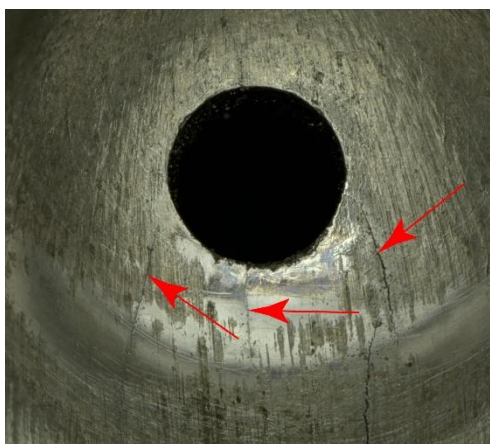
**Figure 3**

5. If cracks are found in the area to be inspected (Figures 3 and 4):
  - A. Contact Lycoming Engines by completing and emailing the attached form to [TechnicalSupport@Lycoming.com](mailto:TechnicalSupport@Lycoming.com) or call Lycoming Technical Support at the phone number on page 1 of this service bulletin.

**Cracks on the Pushrod Socket Side of the Rocker Arm, Around the Oil Squirt Hole**

- B. Replace the damaged rocker arms. Return the damaged rocker arms to Lycoming Engines.
- C. Inspect all removed components for damage.
- D. Reinstall the hydraulic lifters, new shroud tube seals, shroud tubes, push rods, and new rocker arms with new self-locking nuts, per instructions in the Lycoming "76" Series Engines Overhaul Manual (60294-9).
- E. Check dry tappet clearance and adjust as necessary.
- F. Complete this inspection again at next 50-hour oil change until 500 hours of engine operation after rocker arm replacement.

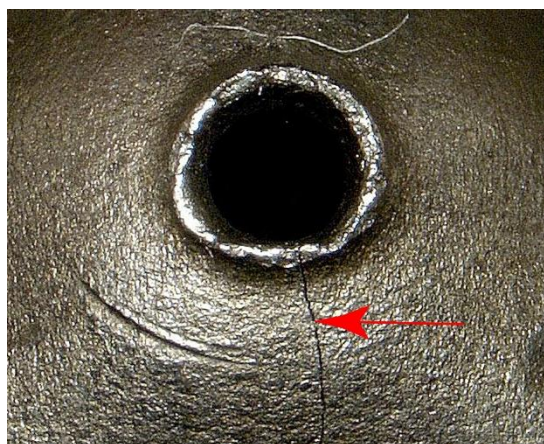
**Figure 4**

**Crack on the Outside of the Rocker Arm, Around the Oil Squirt Hole**

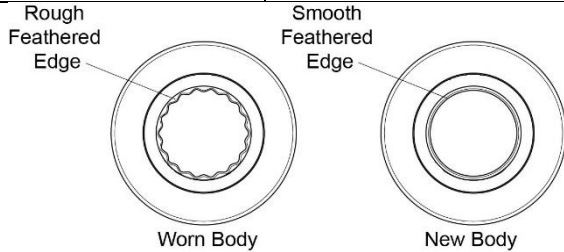
| Task | Findings | Corrective Action |
|---|---|---|
| 1. Examine the interior bore of the lifter body.<br>a. Look for wear at the interior shoulder.<br>b. Look for a feathered or chipped edge around the shoulder (Figure 6) | Wear found at the interior shoulder and/or<br>Feathered or chipped edge around the shoulder | If wear, feathering or chipped edge found, replace with lifter body of the same part number (15B28093) |
| <p style="text-align: center;"><b>Figure 6</b><br/><b>Comparison Between Worn and New Tappet Body</b></p> | | |

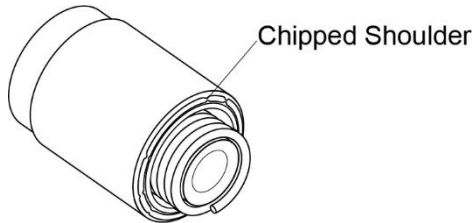
| Task | Findings | Corrective Action |
|---|---|---|
| 1. Examine the plunger for chipping on the shoulder (Figure 7). | | If chipping is found, discard lifter assembly and replace with new lifter assembly (15B28093*) |
| <p style="text-align: center;"><b>Figure 7</b><br/><b>Chipped Shoulder</b></p> | | |

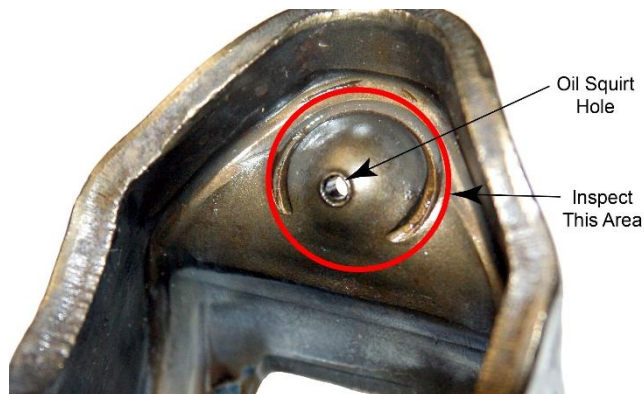
1. Remove the rocker box cover and rocker box cover gasket per instructions in the Lycoming “76” Series Engines Overhaul Manual (60294-9).
2. Clean residual oil from the rocker arm.
3. Use a 10X power magnifying glass to inspect the pushrod socket and the outside of the rocker arm for cracks around the oil squirt hole (Figure 8).

**Figure 8**  
**Area to Inspect**  
**(Outside of the Rocker Arm)**

4. If no cracks are found in the area to be inspected, reinstall the rocker box cover with a new rocker box cover gasket per instructions in the Lycoming “76” Series Engines Overhaul Manual (60294-9).
5. If cracks are found in the area to be inspected (Figure 8), contact Lycoming Engines by completing and emailing the attached form to [TechnicalSupport@Lycoming.com](mailto:TechnicalSupport@Lycoming.com) or call Lycoming Technical Support at the phone number on page 1 of this service bulletin.
