SERVICE INSTRUCTION

Service Instruction No. 1316A (Supersedes Service Instruction No. 1316) Engineering Aspects are FAA Approved

Repair of Oil Cooler By-Pass Valve Seat

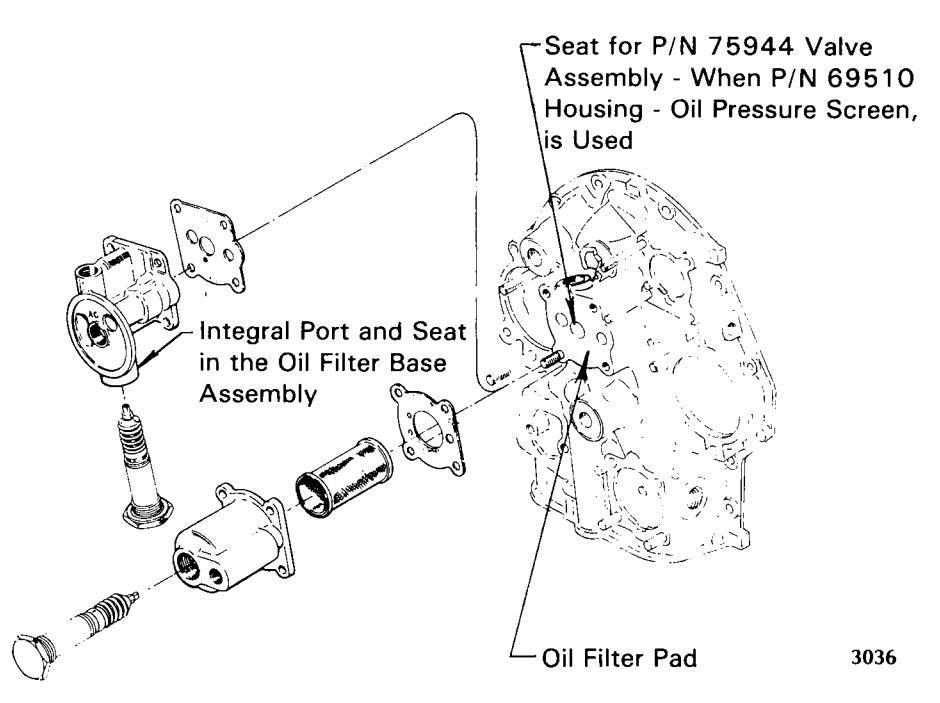
Figure 1.

Individual Magneto Accessory Housing With Optional Oil Filter Base Assembly or Oil Pressure Screen Housing

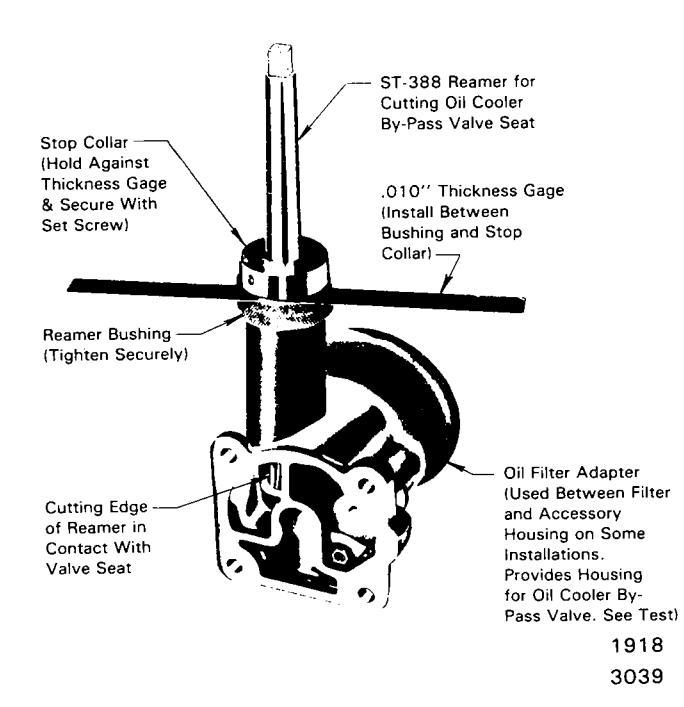
Oil Filter Base Assembly Showing Reamer Cutting Edge in Position

1. Apply a small amount of all-purpose grease on the fluted end of P/N ST-388-1 reamer. Insert the P/N ST-388-1 Reamer thru the ST-388-2 guide bushing and install it in the oil cooler bypass valve housing. Engage the threads of the guide bushing with the threads of the valve housing and tighten the guide bushing firmly. See Figure 4.

2. Insure the chamfered end of the reamer is in contact with the valve seat in the housing.

3. Place a .010 inch thickness gage on top of the bushing. Install the P/N ST-388-3 stop collar on the reamer and move it down against the thickness gauge. Lock the stop collar in place by tightening the $10-32 \times 3/8$ inch set screw on the side of the collar. Remove the thickness gage.
