SERVICE BULLETIN

Service Bulletin No. 601
Engineering Aspects are
FAA (DER) Approved

SUBJECT: Non-Compliant Oil Fill Tubes P/N 77527

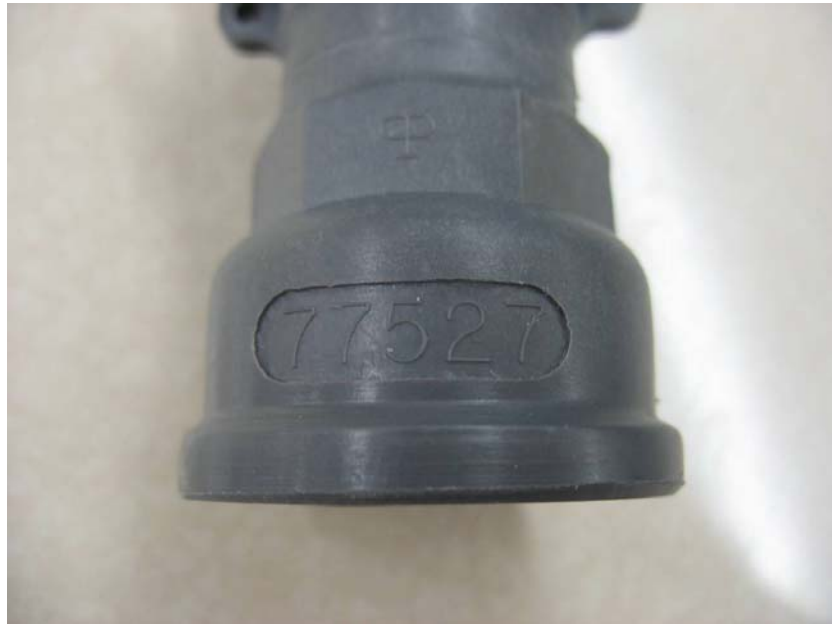
Figure 1
Molded Part Number

Table 1 identifies affected Lycoming engines and serial numbers that have P/N 77527. (The molded part number is on the side of the tube as shown in Figure 1.) Table 2 identifies Lycoming engines that could have P/N 77527 installed as a spare part. Table 3 identifies the company, engine model designation, and serial number of kit engines shipped from Lycoming from May 17, 2011 to November 4, 2011 that included the oil fill tube P/N 77527.

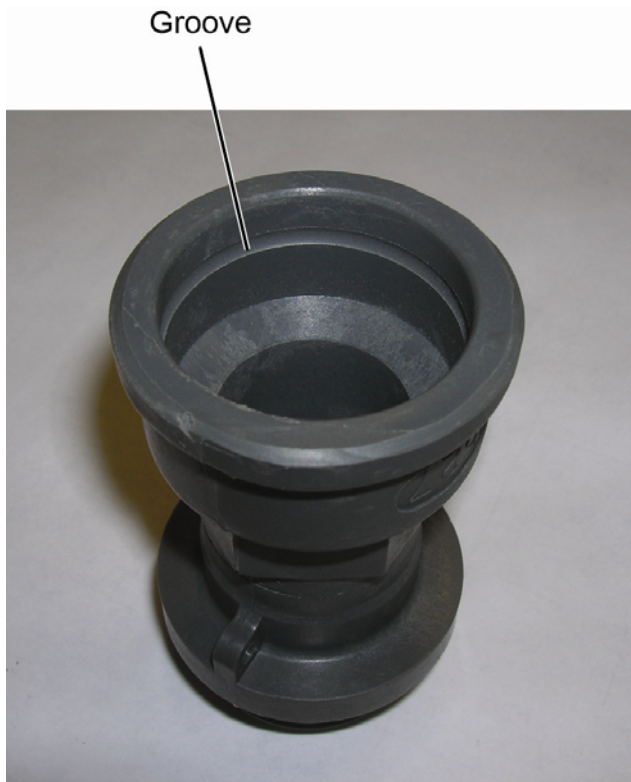
Figure 2
Compliant Oil Fill Tube P/N 77527
(With the Inner Machined Groove)

1. In your spares inventory, examine all oil fill tubes 77527 received between May 17, 2011 and November 4, 2011; look for the inner machined groove. Figure 2 shows the inner machined groove in an oil fill tube. Figure 3 shows an oil fill tube without the inner machined groove.
2. At the next scheduled maintenance event or within the next 50 hours of engine operation (whichever occurs first), on engines identified in Table 1, look for the inner machined groove on the inner diameter of the oil fill tube.
3. If you installed oil fill tube P/N 77527 on any of the engine models in Table 2 between May 17, 2011 and the current date, at the next scheduled maintenance event or within the next 50 hours of engine operation (whichever occurs first) (not to exceed 12 months from the date of this Service Bulletin), look for the inner machined groove on the inner diameter of the oil fill tube.

4. For those who have engine package kits shown in Table 3, look for the inner machined groove on the inner diameter of the oil fill tube.
5. If you find the inner machined groove on the oil fill tube, the oil fill tube is acceptable and can be used. Record your findings and compliance with this Service Bulletin in your engine logbook.
6. If you find any oil fill tube P/N 77527 that does not have the inner machined groove:
 - a. Remove the oil fill tube from the spares inventory or from the engine.
 - b. Return the non-compliant oil fill tube(s) to Lycoming Engines for an exchange through the normal warranty procedures up to 1 year from the date of this Service Bulletin.
 - c. Record your findings and compliance with this Service Bulletin in your engine logbook.
 - d. Contact an authorized Lycoming distributor.

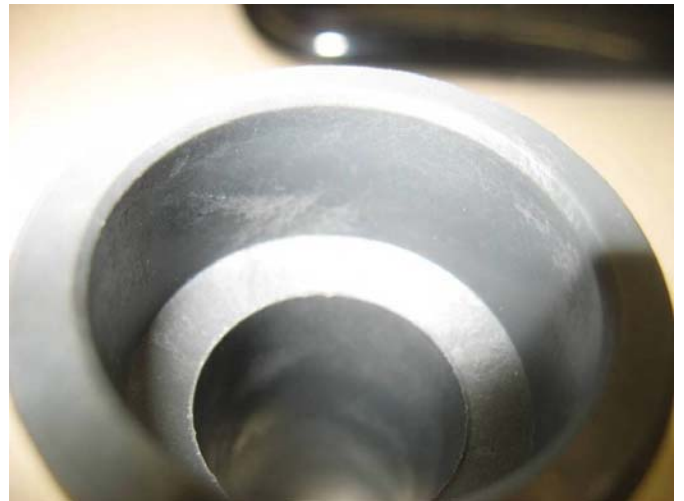
This Service Bulletin is notification of required action for non-compliant oil fill tubes P/N 77527 sent from Lycoming Engines from May 17, 2011 to November 4, 2011. The inner machined groove is missing on the non-compliant oil fill tube and must be returned to Lycoming Engines for replacement under normal warranty procedures within 1 year of the date of this Service Bulletin.

Figure 3
Non-Compliant Oil Fill Tube P/N 77527
(Without the Inner Machined Groove)
