MANDATORY SERVICE BULLETIN

DATE: March 27, 2006 Service Bulletin No. 568

SUBJECT: Reprint of Slick Aircraft Products Service Bulletin No. SB1-88B

SUBJECT: Periodic Inspection of Slick Models 6320, 6324, 6360, 6361, 6363, and 6365 Pressurized Magnetos

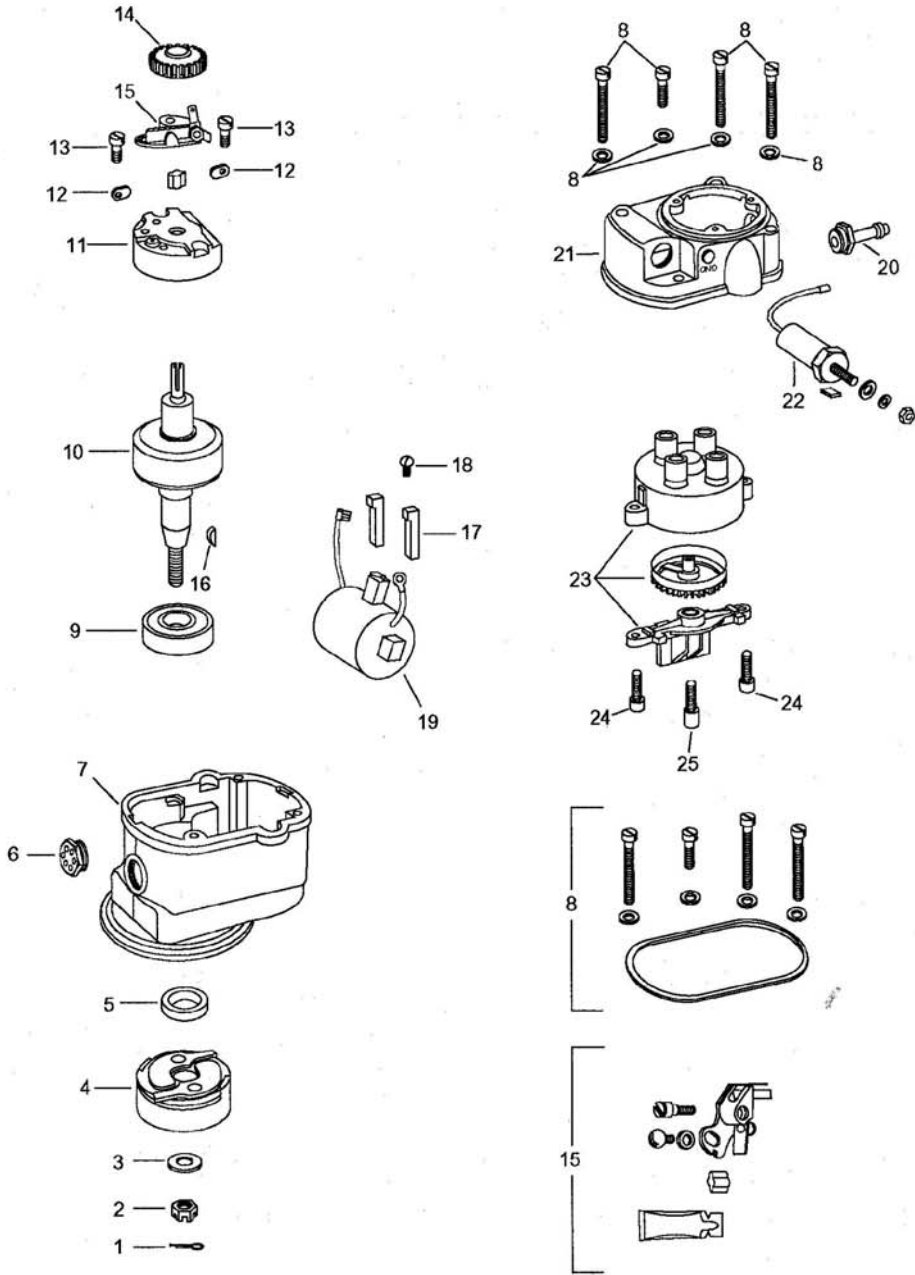
Exploded View

- (1) Check for rust and corrosion on screws (8, 13, 18, 24), bearing cap hold down clamps (12), rotor shaft (10), breaker point assembly (15), frame and coil laminations (19), etc. See Figure 1. Rust and corrosion are signs of contamination and require component cleaning or replacement (reference paragraphs 3.B and C of this bulletin and Slick Maintenance and Overhaul Manual L-1037.
