MANDATORY
SERVICE BULLETIN

Service Bulletin No. 594

SUBJECT: Reprint of Hartzell Engine Technologies LLC (HET) (formerly Kelly Aerospace) Mandatory Service Bulletin 040 A.

TURBOCHARGER CHRA CONTAMINATION

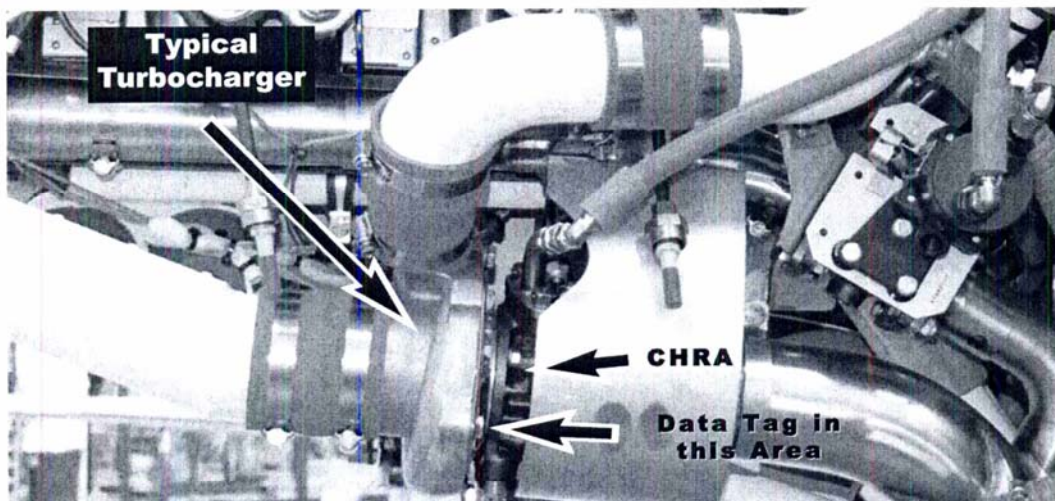
Figure 1 - Typical Turbo Installation

2. Refer to Table 1 to determine if the turbocharger being inspected is an affected part number. Observe the part number found on the data plate. If the affected part number **does not** appear, go to the "Return to Service" section step 3 & 4. If an affected part number **does** appear, continue with step 3. (See Figure 1 for typical turbocharger installation.)
