# MANDATORY

# SERVICE BULLETIN

Supplement No. 1

Service Bulletin No. 475C

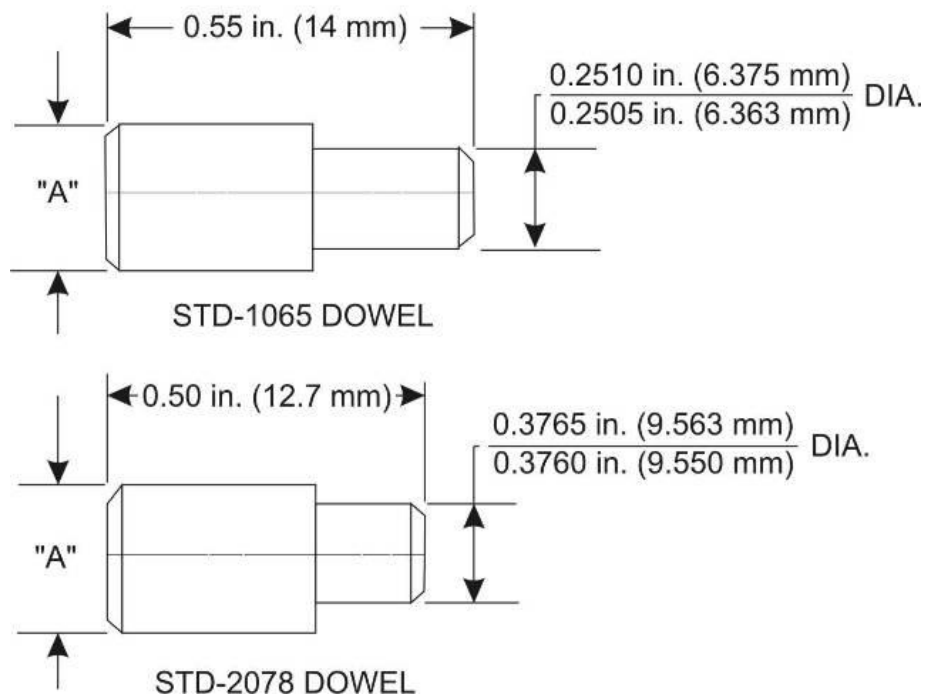
**Figure 8**  
**Details of Crankshaft Alignment Dowel**

**NOTICE:** There are two basic alignment dowel part numbers, STD-1065 (Figure 6) and STD-2078 (Figure 7). Each type of alignment dowel can have oversized variations as shown in Table 3. Figure 8 shows the details of the two crankshaft alignment dowels: STD-1065 and STD-2078.

Alignment Dowel Part No.	Size Code on Alignment Dowel	Diameter of Alignment Dowel "A" (Figure 8)		Diameter of Alignment Dowel Hole in Crankshaft	
		in.	mm	in.	mm
STD-1065*	None	0.3095 to 0.3100	7.861 to 7.874	0.3085 to 0.3095	7.836 to 7.871
STD-1065-P02	P02	0.3115 to 0.3120	7.921 to 7.925	0.3105 to 0.3115	7.887 to 7.925
STD-1065-P05	P05	0.3145 to 0.3150	7.988 to 8.001	0.3135 to 0.3145	7.963 to 7.988
STD-1065-P10	P10	0.3195 to 0.3200	8.115 to 8.128	0.3185 to 0.3195	8.090 to 8.115
STD-2078**	None	0.3760 to 0.3765	9.550 to 9.563	0.3750 to 0.3760	9.525 to 9.550
STD-2078-P02	P02	0.3780 to 0.3785	9.601 to 9.614	0.3770 to 0.3780	9.576 to 9.601
STD-2078-P05	P05	0.3810 to 0.3815	9.677 to 9.690	0.3800 to 0.3810	9.652 to 9.677
STD-2078-P10	P10	0.3860 to 0.3865	9.804 to 9.817	0.3850 to 0.3860	9.779 to 9.804
