SERVICE BULLETIN

DATE: June 11, 2025 Service Bulletin No. 630B
(Supersedes Service Bulletin No. 630A)
Engineering design data in this service document is FAA approved.

SUBJECT: Connecting Rod Bushing Inspection After Cylinder Removal

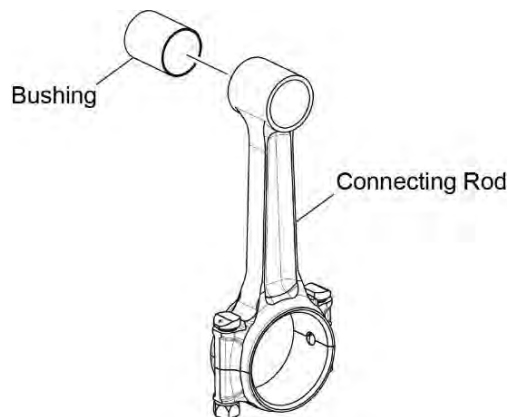
Figure 1
Bushing in Connecting Rod

This Section includes a mandatory inspection of the connecting rod bushing (in the smaller end of the connecting rod as shown in Figure 1) that must be done any time a cylinder is removed from a Lycoming engine.

After cylinder removal, remove the piston and examine the connecting rod bushing for damage. If damaged, remove, discard and replace the connecting rod bushing.

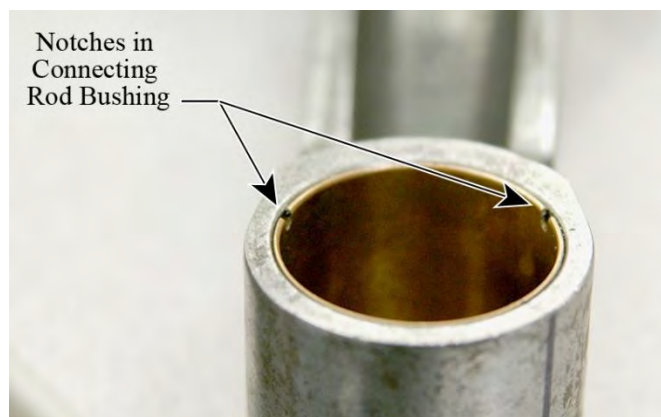
Figure 10

Some connecting rod bushings have a notch or notches in the edge of the bushing (Figure 10). Do not confuse the notch or notches with the split line in the bushing.

Notches in the Connecting Rod Bushing

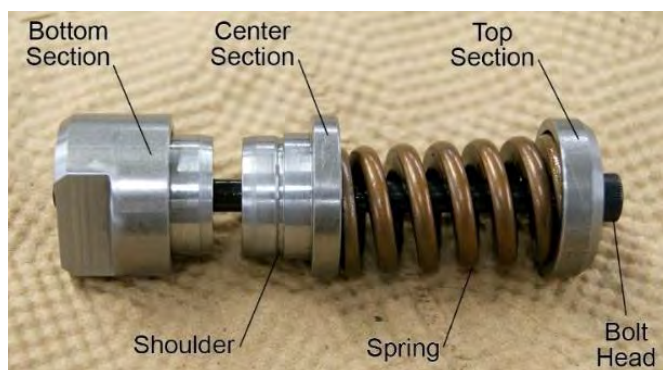
Figure 12

ST-531, Connecting Rod Bushing Press-Out Verification Tool

1. Remove the bottom section from the ST-531, Connecting Rod Bushing Press-Out Verification Tool (Figure 12) (available from Lycoming Engines).

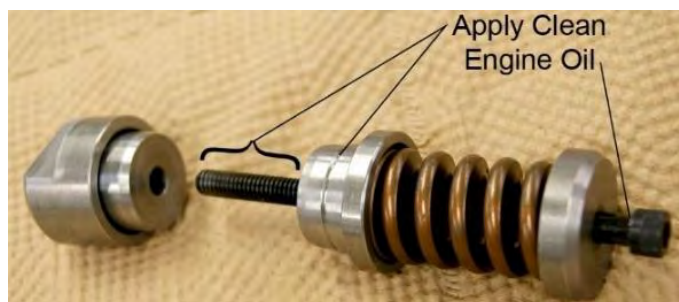
Figure 13

ST-531 Lubrication Points

2. Apply a coating of clean engine oil to the threads of the bolt, the shoulder on the center section, and under the head of the bolt of the ST-531 (Figure 13).
3. Install the tool in the piston end of the connecting rod (Figure 14) and reinstall the bottom section.

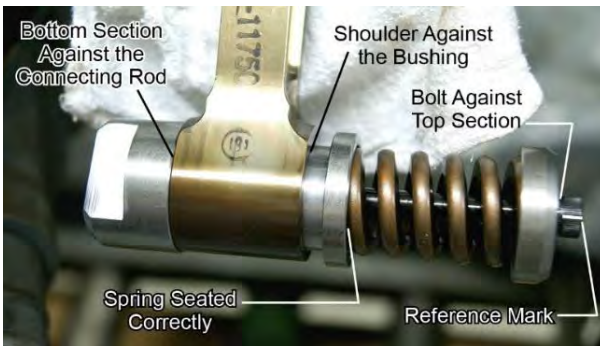
Figure 16
ST-531 Correctly Installed in the Connecting Rod

5. Make sure:
- The bottom section of the tool is in contact with the connecting rod
 - The shoulder of the center section of the tool is in contact with the connecting rod bushing
 - The head of the bolt is in contact with the top section of the tool
 - The spring is seated correctly in the tool as shown in Figure 16. Figure 17 shows **incorrect** seating of the spring.

6. Use a marker to make a reference mark on the bolt head (Figure 16) to ensure an accurate count of the required number of turns during the procedure.
7. Measure the distance from the collar on the center section of the ST-531 to the edge of the connecting rod (Figure 18).

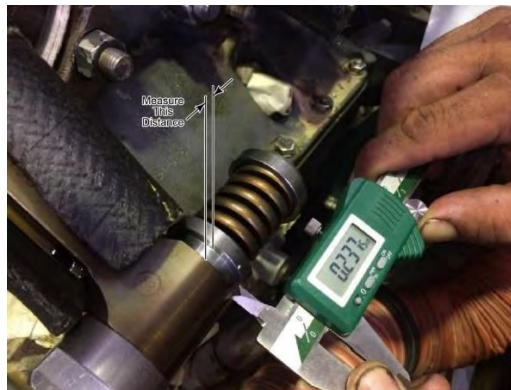
Figure 18
Measure this Distance with the Bolt Finger-Tight

9. Re-measure the distance from the collar on the center section of the ST-531 to the edge of the connecting rod (Figure 18).
10. If the collar to connecting rod measurement has changed after turning the bolt six full turns, the connecting rod bushing has moved.
