## SERVICE BULLETIN

DATE: August 24, 2026 Service Bulletin No. 671  
Engineering Aspects are FAA Approved

SUBJECT: Fuel Pump Leak Inspection and Diaphragm Replacement,  
Hartzell Engine Tech (HET) Alert Service Bulletin No.233

### 200F, 201F, 202F, & 500F Fuel Pump Leak Inspection and Diaphragm Replacement

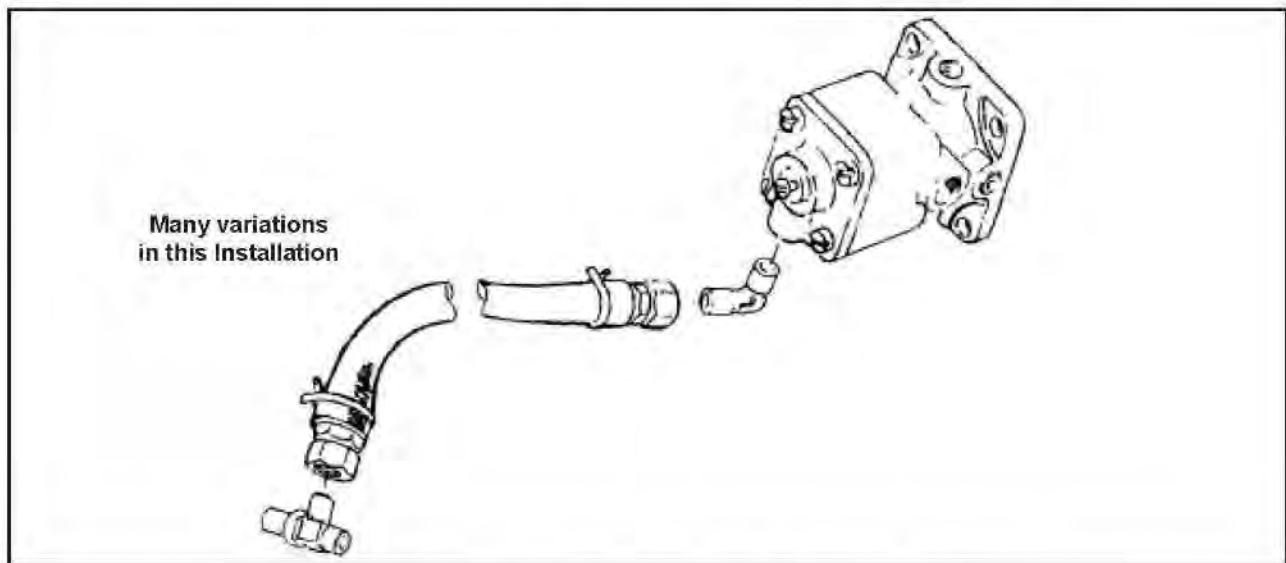
Figure 5 - Typical HET 201F Fuel Pump Plumbed to Upper Deck Reference

- (1) The HET series fuel pumps use the reference vent port in several ways. The port may have an orifice plug installed, a fitting for an upper deck reference line, or a fitting to connect to the engine upper deck reference.
  - (a) Inspection of the orifice plug requires only a visual inspection. Look around the plug and into the orifice for fuel or blue dye stains. Refer to Fig. 1, Fig. 2, or Fig. 3.
  - (b) Inspection of the upper deck reference line requires that the line be disconnected and the inside of the fitting be inspected for fuel or blue dye stains. Refer to Fig. 5 and 6.
  - (c) Inspection of the engine turbocharger reference line will require that the "B" nut be removed and the inside of the fitting be inspected for fuel or blue dye stains.
