# SERVICE LETTER

Service Letter No. L248  
January 14, 2011

TO: All Owners and Operators of Lycoming O-235 Aircraft Engines  
SUBJECT: O-235 Crankcase Design Upgrade

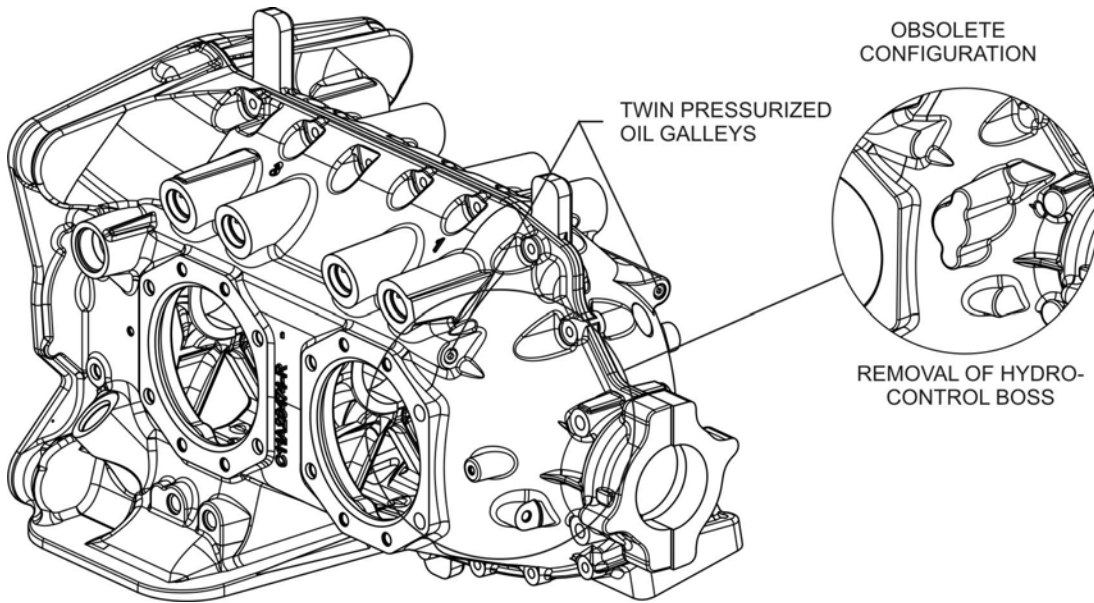
**Figure 1. Twin Pressurized Oil Galleys,  
Tappet Boss Diameter Enlarged**

Lycoming Engines has released a new crankcase design for the O-235 engines. The new crankcase uses twin pressurized main oil galleys (Figure 1) to supply oil to both banks of tappets and all camshaft journals. The new design removed the hydro-control boss and oil catch troughs (Figure 2). In the existing O-235 crankcase, oil drains by gravity into the catch troughs through tappet bores to lubricate tappets and the camshaft. Plugs also are installed on the new crankcase. Refer to Figures 3 and 4.

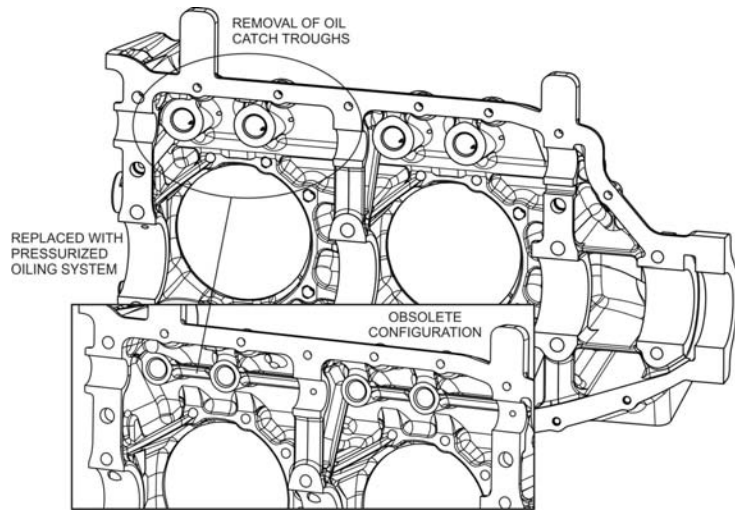
**Figure 2. Pressurized Oiling System**

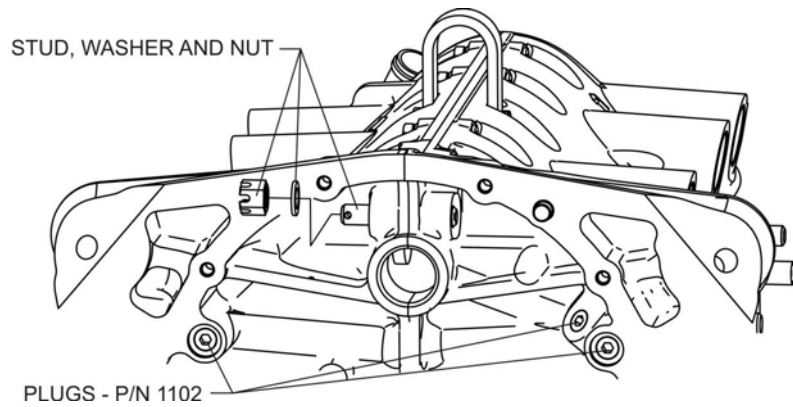
**Figure 3. New Stud, Washer and Nut on Rear of Crankcase**

A new stud, washer and nut, installed on the rear of the crankcase hold the crankcase halves together. Refer to Figure 3.

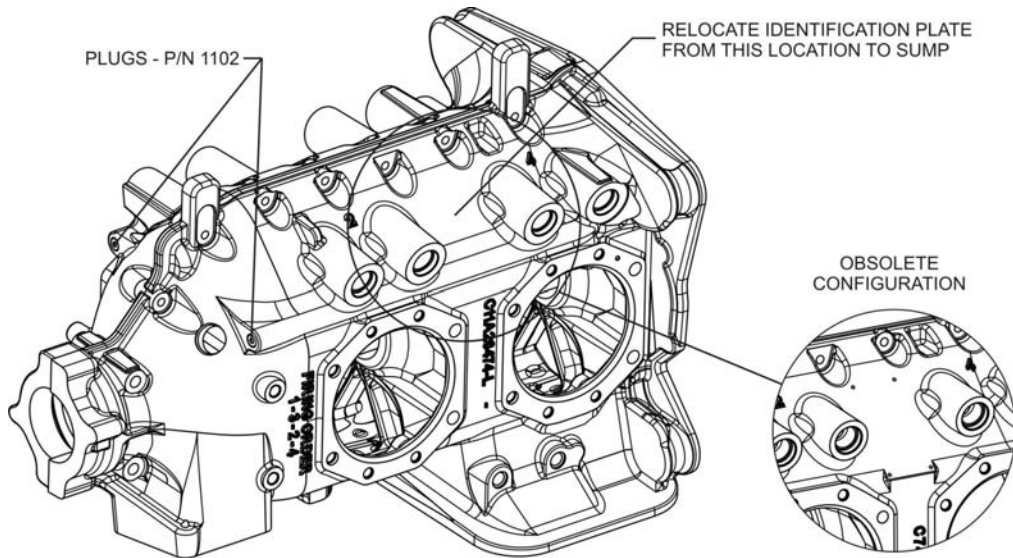
**Figure 4. Location of Identification Plate on Old O-235 Crankcase**

When replacing the old O-235 crankcase with the new O-235 crankcase, the engine identification plate must be removed from the old crankcase (Figure 4) and installed on the oil sump of the new O-235 crankcase where shown in Figure 5. The engine identification plate can be removed one of two ways:

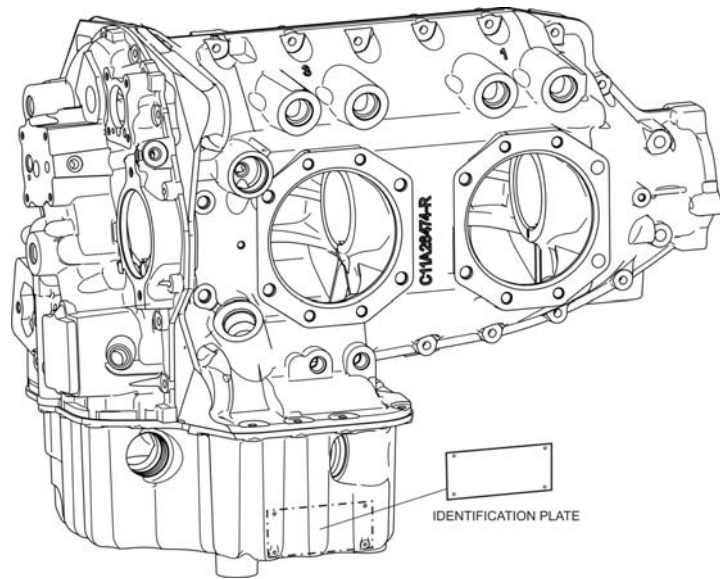
**Figure 5. Relocate Identification Plate to Sump**

The oil sump already has four blind pre-drilled holes for installing the engine identification plate with the four new drive studs P/N STD-1901. Install the engine identification plate on the oil sump of the new crankcase aligned with the four holes in the location shown in Figure 5. To securely attach the engine identification plate to the oil sump, install the four drive studs, one in each of the four predrilled holes, using a drift and a hammer.
