MANDATORY SERVICE BULLETIN

DATE: November 13, 2009 Service Bulletin No. 590A
(Supersedes Service Bulletin No. 590)
Engineering Aspects are
FAA Approved

SUBJECT: Use of Aircraft Boost Pump with Kelly Aerospace 200F Series (Lycoming P/N 62E23185, 62E23186, 62E23187, 62E23188, 62E23189) Fuel Pumps

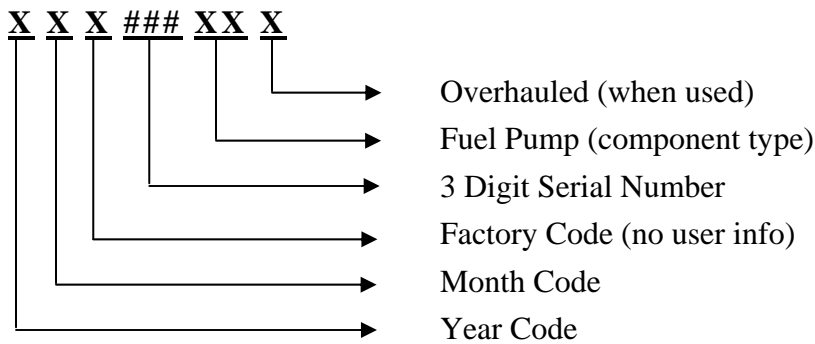
NOTE 1: The determination of the fuel pump serial number is as follows:

YEAR CODE	K = 2007, L = 2008, M = 2009, ETC.
MONTH CODE	A = JANUARY, B = FEBRUARY, C = MARCH, ETC.
SERIAL NUMBER	3 - DIGIT SEQUENTIAL NUMBER

PRODUCTION	FACTORY REBUILT
PART NUMBER:	200F-5004	200F-5004R
SERIAL NUMBER:	MAN001FP	KBN001FPR
DATE OF MFG.:	January, 2009	February, 2007

NOTE 2: The fuel pump model and serial number can be found on the fuel pump identification plate.
