# **Engine Maintenance Manual (Principal Manual)**

**TEO-540-C1A Engine**

Part No. MM-TEO-540-C1A Rev 5

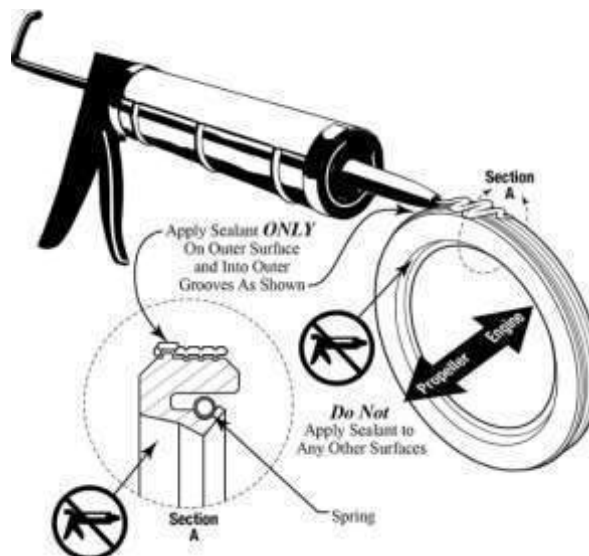
**Figure 29**  
**Where to Apply Sealant**

- S. Do not allow any sealant to contact the crankshaft or the seal lip. Use acetone and ethyl alcohol to remove any sealant that contacts the crankshaft or seal lip area. (Figure 29)
- T. Allow sealant to cure per the manufacturer's instructions.
- U. Install the starter ring gear support on the crankshaft propeller flange per instructions in the applicable Lycoming Engines' manual.

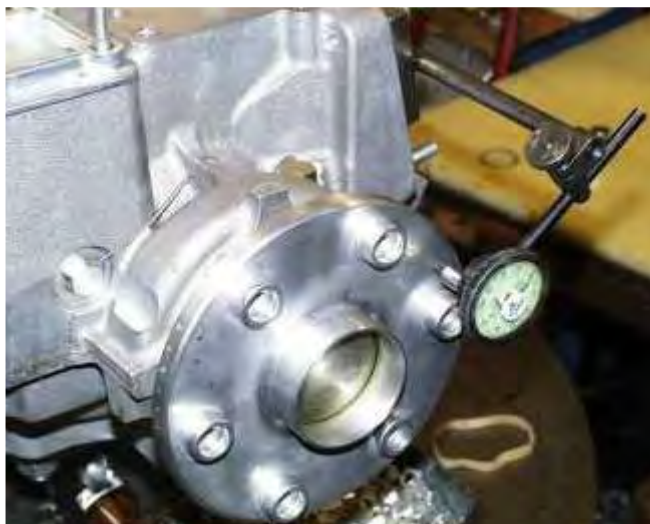
**Figure 101**  
**Crankshaft End Play Check**

- H. Read the end play measurement indicated by the gage.

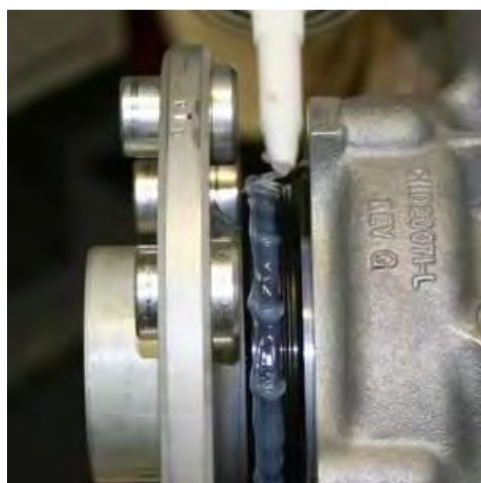
**Figure 104**  
Apply the Sealant to the Oil Seal

(4) Use a brush and wear butyl rubber gloves to apply a liberal coating of Dow Corning® 737 Neutral Cure Sealant to the outside diameter of the oil seal (Figure 104) to allow the excess sealant to squeeze out between the crankcase and the oil seal when the oil seal is installed.
