# SERVICE BULLETIN

DATE: June 1, 2011 Service Bulletin No. 598A  
(Supersedes Service Bulletin No. 598)  
Engineering Aspects are  
FAA (DER) Approved

SUBJECT: V-Band Clamp P/N LW-12125-3 (Aeroquip P/N NH1008723-10) and LW-12093-6 (Aeroquip P/N MVT69183-225) on Turbocharged Engines

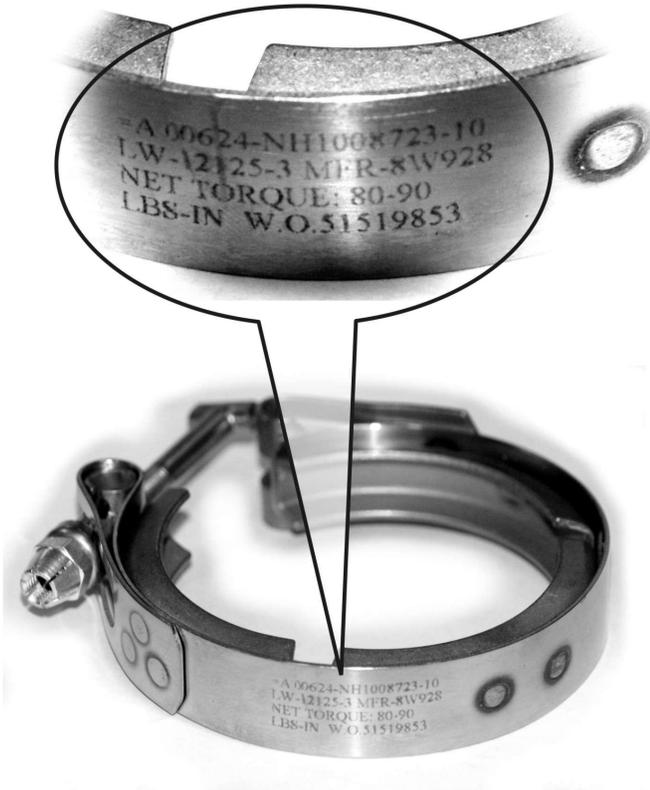
Figure 1

- V-band clamp P/N LW-12125-3 (Aeroquip P/N NH1008723-10) with W.O. 51519853 stamped on it as shown in Figure 1.
- V-band clamp P/N LW-12093-6 (Aeroquip P/N MVT69183-225) with W.O. 51599475 stamped on it as shown in Figure 2.

Both of these V-band clamps could have unacceptable spot welds which could lead to an overstress failure once thermal expansion starts.

W.O. Stamp on V-Band Clamp P/N LW-12125-3  
(Aeroquip P/N NH1008723-10)

2. Look at the stamped data on P/N LW-12125-3 for W.O. 51519853 (Figure 1) and P/N LW-12093-6 for W.O. 51599475 (Figure 2).
3. If your spare parts inventory and engine maintenance records show that you did not receive clamps P/N LW-12125-3 or P/N LW-12093-6 within the suspect time frame, just record your findings of this check in compliance with this Service Bulletin in the engine logbook.
4. If it is possible that procurement of these parts occurred within the suspect time frame and now could either be in your spare parts inventory or installed on an engine model identified in Tables 1 or 2, you must identify and collect all of the suspect clamps as follows:
  - a. Remove the suspect clamps P/N LW-12125-3 stamped with W.O. 51519853 and P/N LW-12093-6 stamped with W.O. 51599475 from your spare parts inventory.

- b. If you have any of the engine models identified in Tables 1 and 2, examine the stamped data on the clamps for W.O. 51519853 (See Figure 1) or W.O. 51599475 (See Figure 2).
  - (1) If the W.O. data stamped on the clamp is NOT 51519853 or 51599475, keep the clamp installed. Make sure the clamp is torqued as per the latest revision of Service Instruction No. 1238.
  - (2) If either W.O. 51519853 or W.O. 51599475 is stamped on the clamp, or if you cannot read the stamped data:
    - (a) Remove the suspect clamp(s) P/N LW-12125-3 and P/N LW-12093-6 from the engine.
    - (b) Contact an authorized Lycoming distributor for instructions where to send suspect parts and get replacement parts.

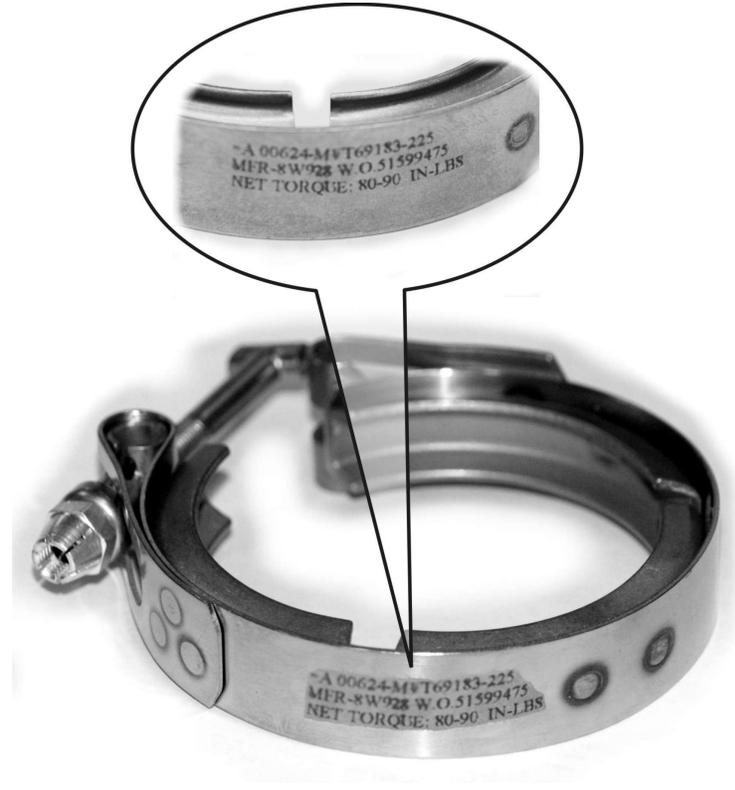
Figure 2

W.O. Stamp on V-Band Clamp P/N LW-12093-6  
(Aeroquip P/N MVT69183-225)
